National Highway
Traffic Safety
Administration

Case Vehicle (A): 1998 Chevrolet
 Type: Blazer LS, 4 x 4, 4-door SUV
 Driver: 36-year-old female
 CDC: 12-FZEW-2, 12-LBAS-2

GENERAL VEHICLE DAMAGE AND ESTIMATED CRASH SEVERITIES

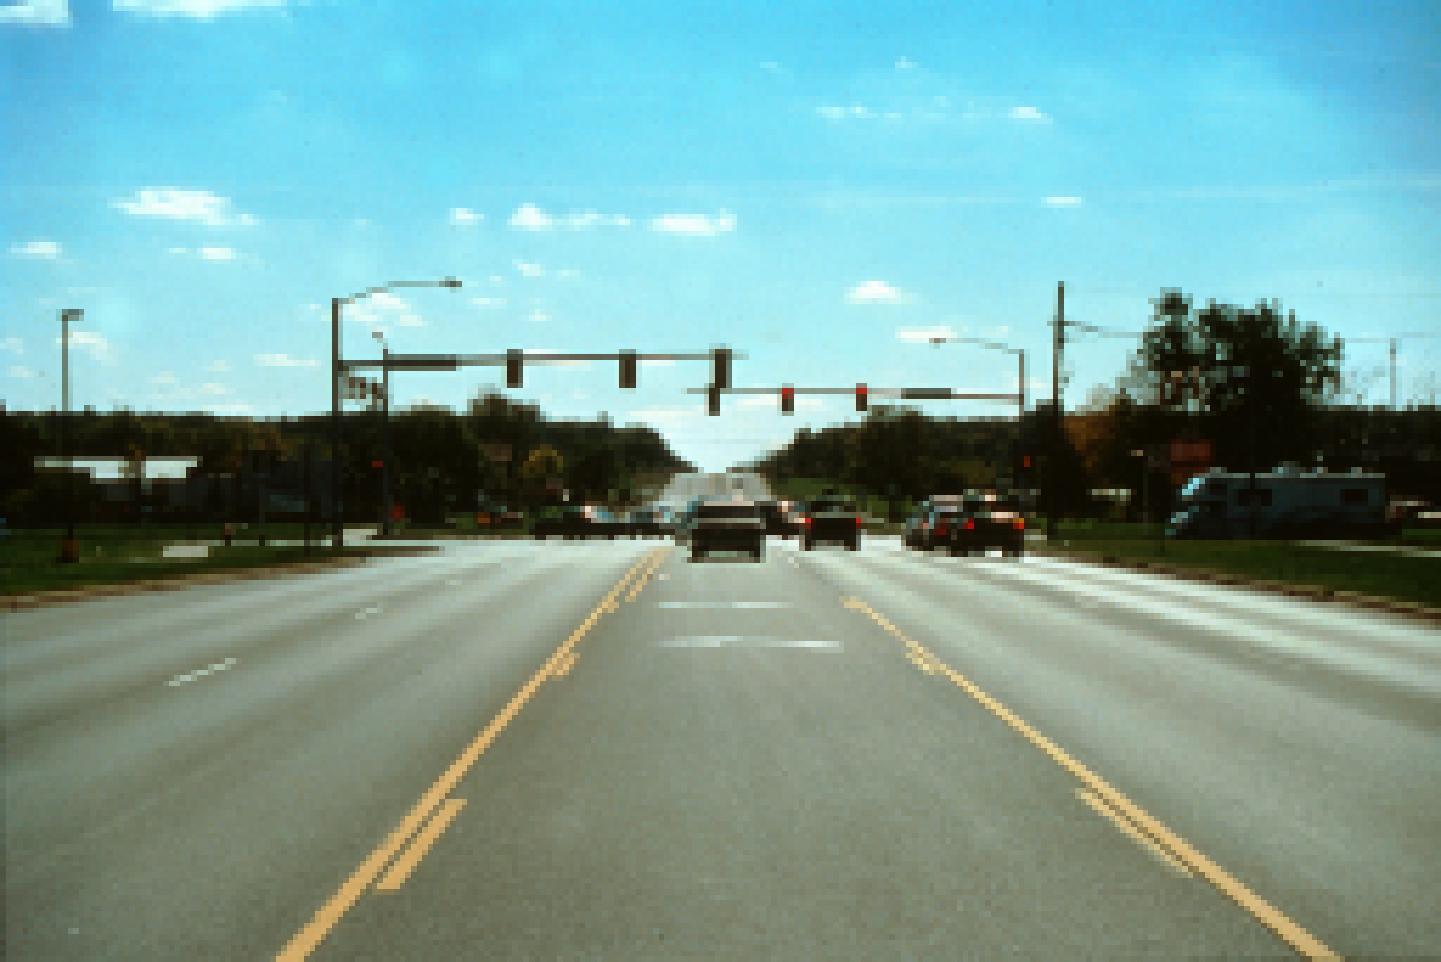
PN 21800 #1

(Slide 1) It was daylight, the sky was clear, and (slide 2) the five-lane, asphalt road surface was dry and free of defects. Case vehicle (A) was traveling south at an unknown speed in the center turn lane. Vehicle (B) had also been traveling south and was stopped in front of case vehicle (A) in the center turn lane. Vehicle (C) was traveling north in the left northbound lane. The driver of case vehicle (A) had undergone invitro fertilization earlier on the same day and this reportedly caused her to have a syncopal episode. As a result, case vehicle (A) drifted to the left and the driver failed to stop behind vehicle (B). The right front of case vehicle (A) struck the rear of vehicle (B). Case vehicle (A) then rotated clockwise, causing the left rear of the vehicle to enter the left northbound lane, where it was struck by vehicle (C). The drivers of case vehicle (A) and vehicle (B) were transported by ambulance to a regional level-one trauma center where they were treated and released. The driver of vehicle (C) did not sustain any injury.

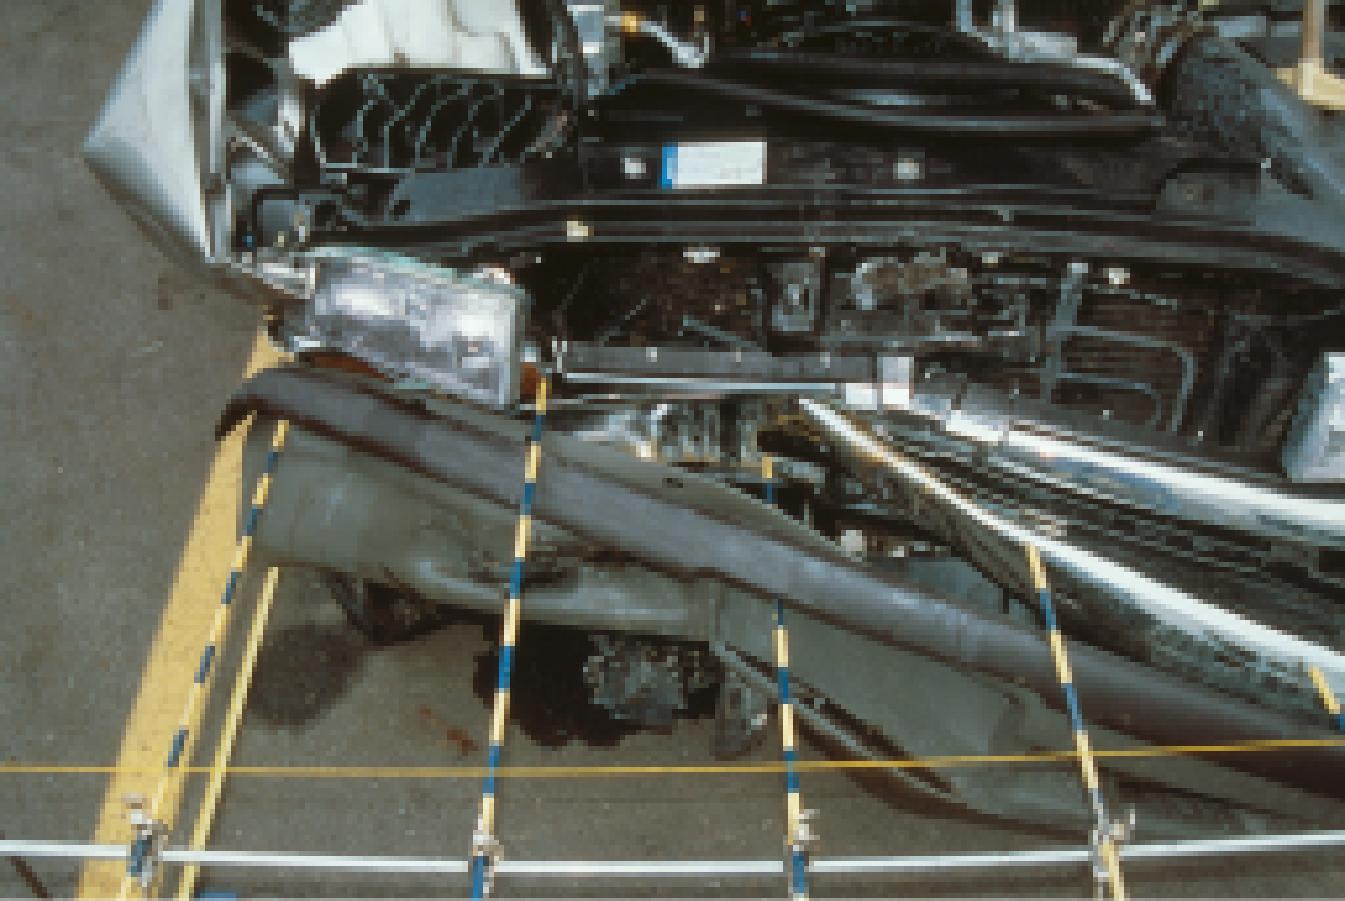
PN 21800 #3
Best Available

(Slide 3) Overall damage to case vehicle (A) was moderate. (Slide 4) Direct damage to case vehicle (A) from the frontal impact began at the right-front bumper corner and extended 85 cm to the left, resulting in 56-percent vehicle overlap. The maximum crush from the frontal impact was 48 cm and occurred just to the right of the bumper center. (Slide 5) Direct damage to case vehicle (A) from the second impact began at the left-rear bumper corner and continued 77-cm forward. The maximum crush was 4 cm and occurred just forward of the rear taillight.

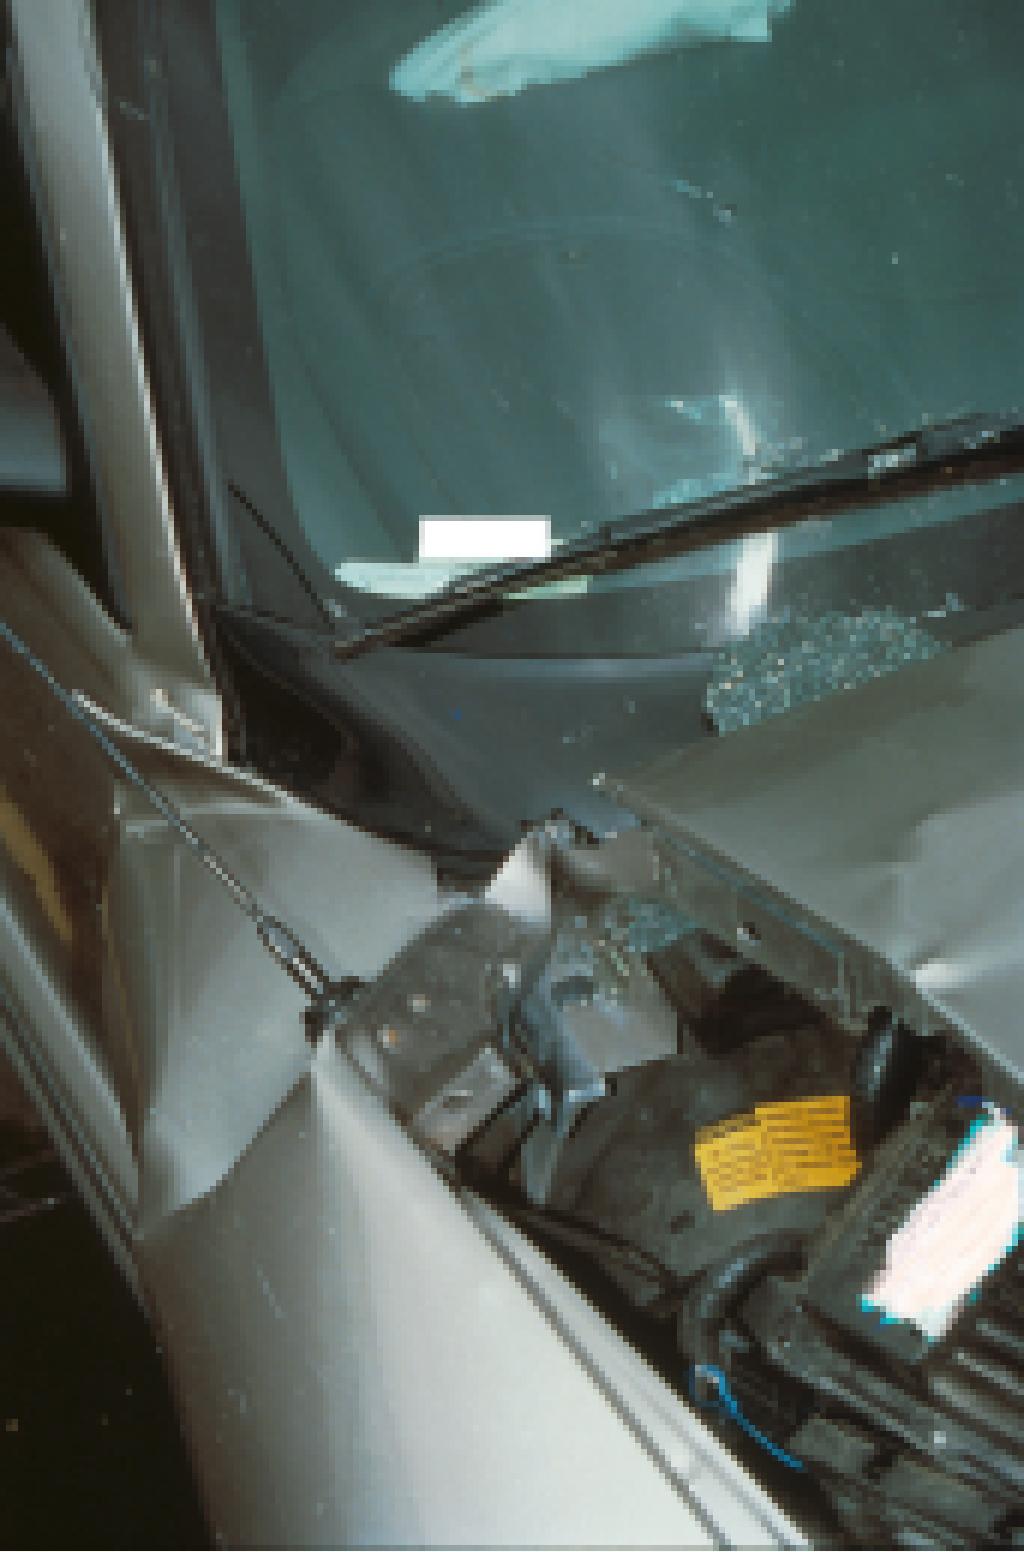
PN21800 #10

(Slide 10) In the front, the right headlight assembly, the grille, the hood, (slide 11) the right hood hinge, and the hood latch were damaged. The hood latch was jammed closed and was pried open by rescue or towing personnel. (Slide 12) The rear edge of the hood was elevated and it contacted the cowl, which contacted and cracked the windshield. (Slide 13) The right side of the engine compartment was crushed rearward.

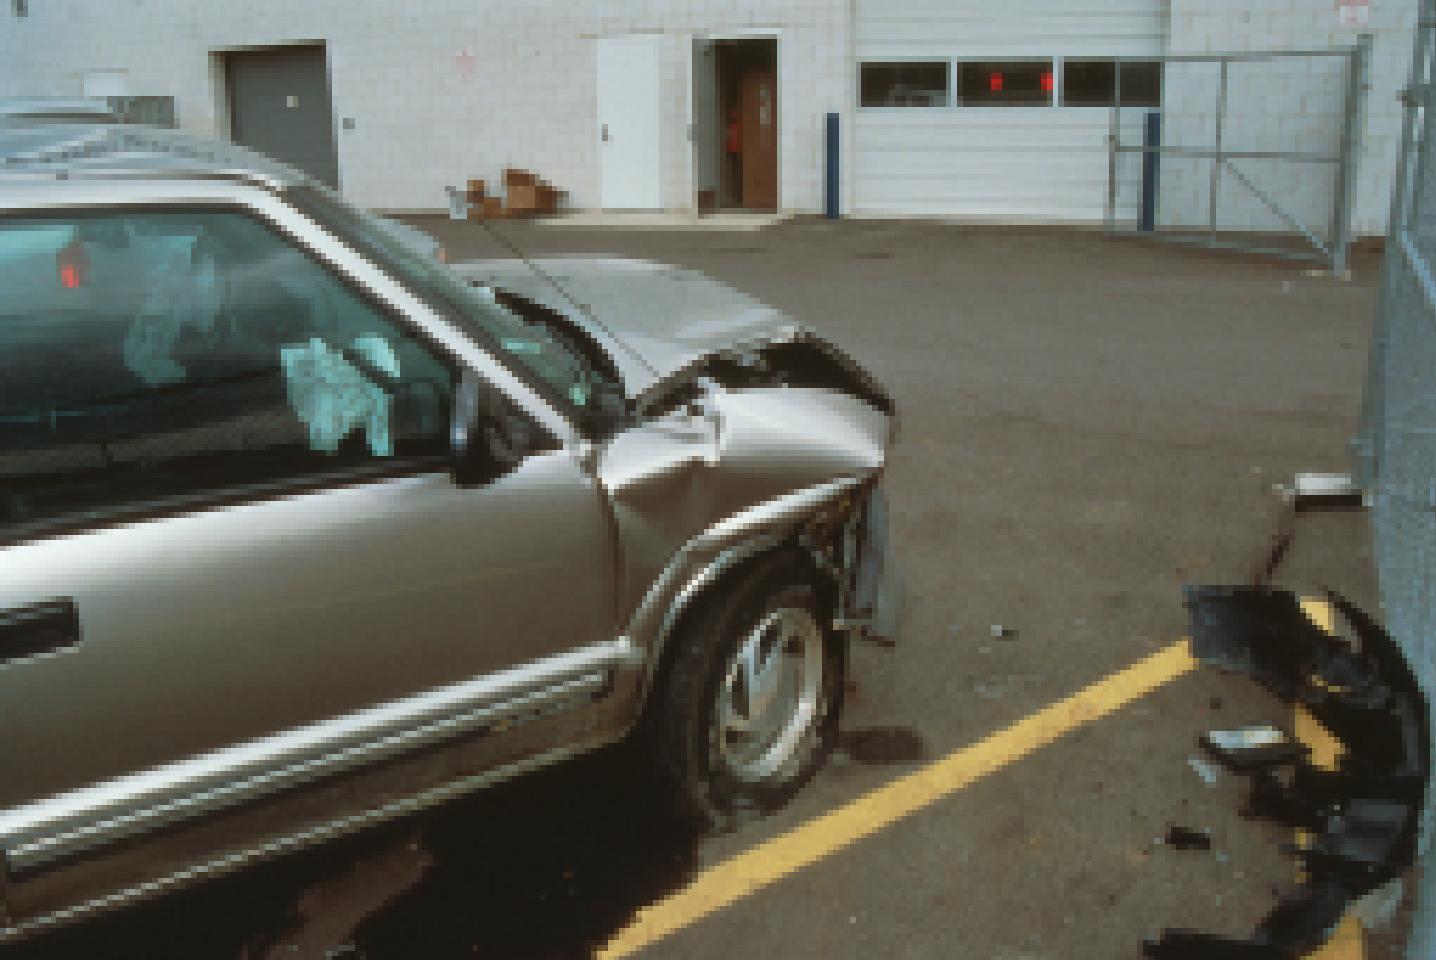
PN21800#17

On the right side, (slide 17) the front fender, (slide 18) the upper and lower A-pillar, and (slide 19) the roof siderail were damaged. (Slide 20) There was no other right-side damage, but the right wheelbase was reduced 6 cm.

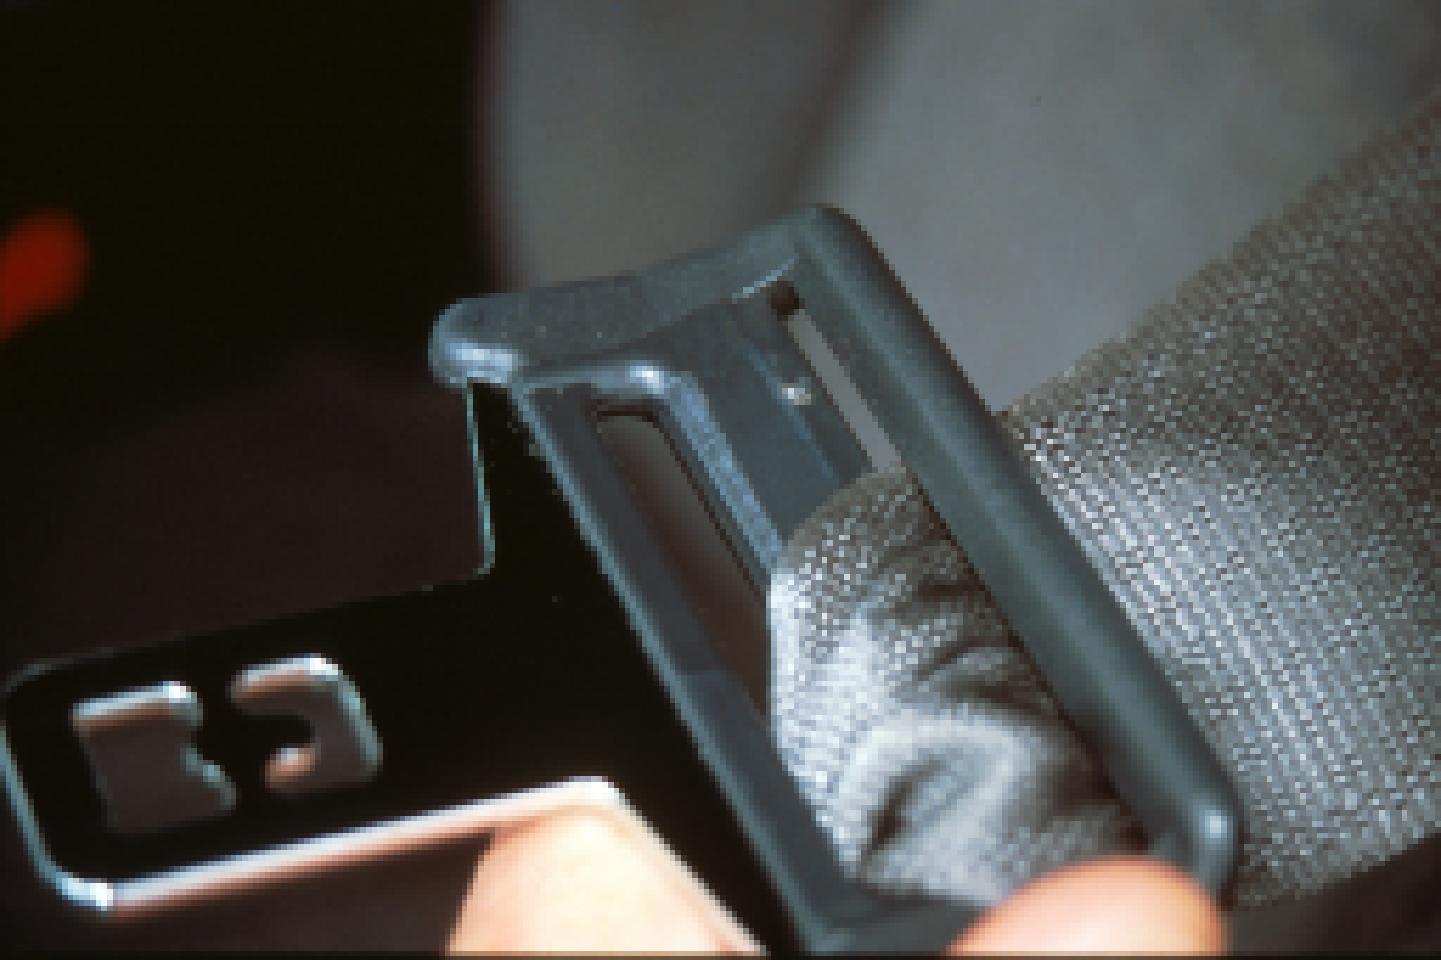
PN 21800 #40

(Slide 38) The 5-ft, 9-in, 135-lb, 36-year-old female driver was wearing the three-point belt and the (slide 39) frontal-impact airbag deployed. (Slide 40) There was a small webbing imprint on the plastic D-ring, (slide 41) a webbing imprint on the plastic continuous loop, (slide 42) plastic transferred onto the belt webbing from the continuous loop, and (slide 43) the stitching of the energy-management loop was torn out, indicating belt use at the time of the crash.

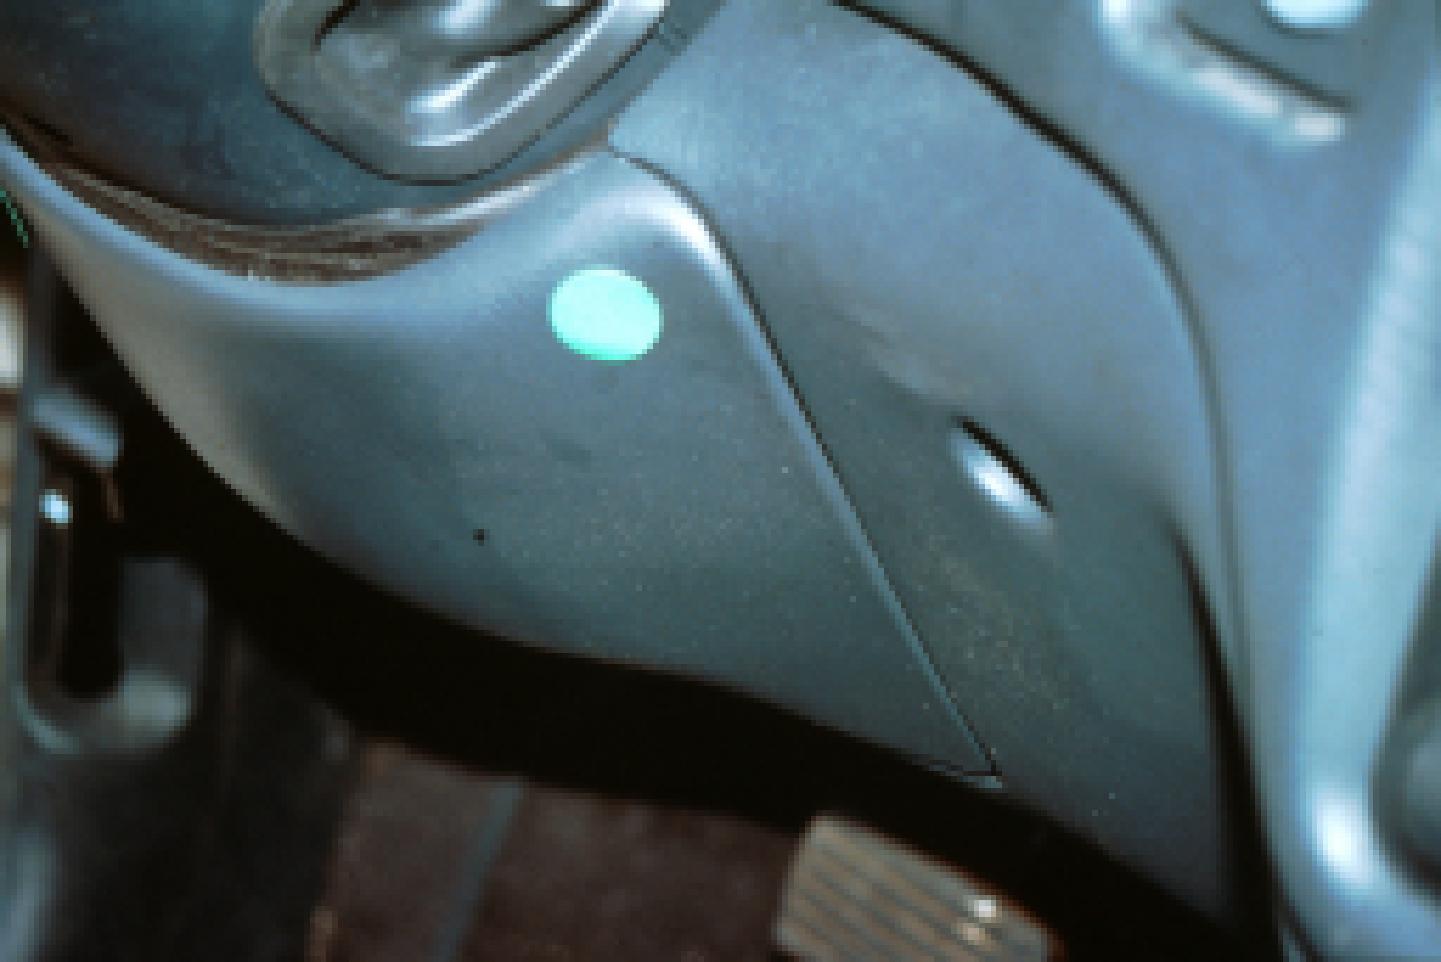
PN21800 #44
Best Available

On impact, the driver moved forward and slightly to the right relative to the vehicle interior, into the belt restraint and airbag. (Slide 44) There was lipstick and makeup transferred onto the airbag fabric just to the right of the circle of tether stitching. The driver sustained a contusion to her right knee, due to contact with the knee bolster, (slide 45) as evidenced by scuff marks on the knee bolster cover to the right of the steering column. She sustained a contusion across her abdomen, probably due to contact by the lap belt. (Slide 46) There were scuff marks on the knee bolster cover to the left of the steering column, but no injuries were reported from these potential contact points.
